PFAS-CONTAMINATION MANAGEMENT GEILENKIRCHEN-TEVEREN

Commissie AWACS Limburg, 28 June 2023

BAIUDBw, Germany

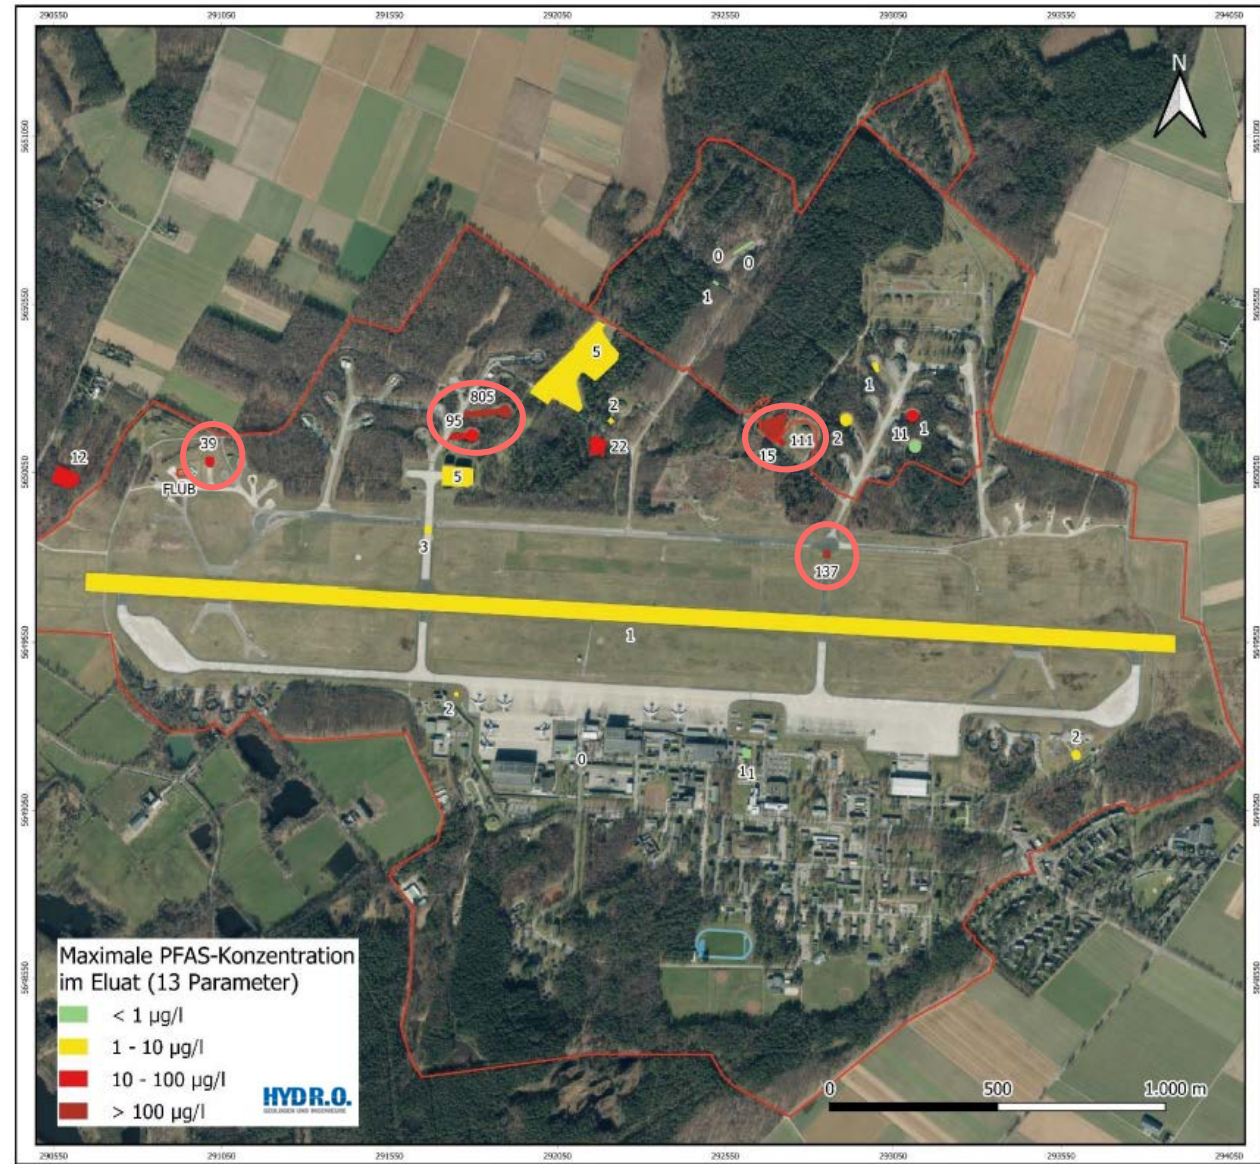
Results

- PFAS confirmed in varying concentrations in the majority of soil samples
- five contamination sites identified as potential hotspots
 - firefighting training areas
 - fire pond
 - stand-by area firefighters
- Main pollutant: PFOS

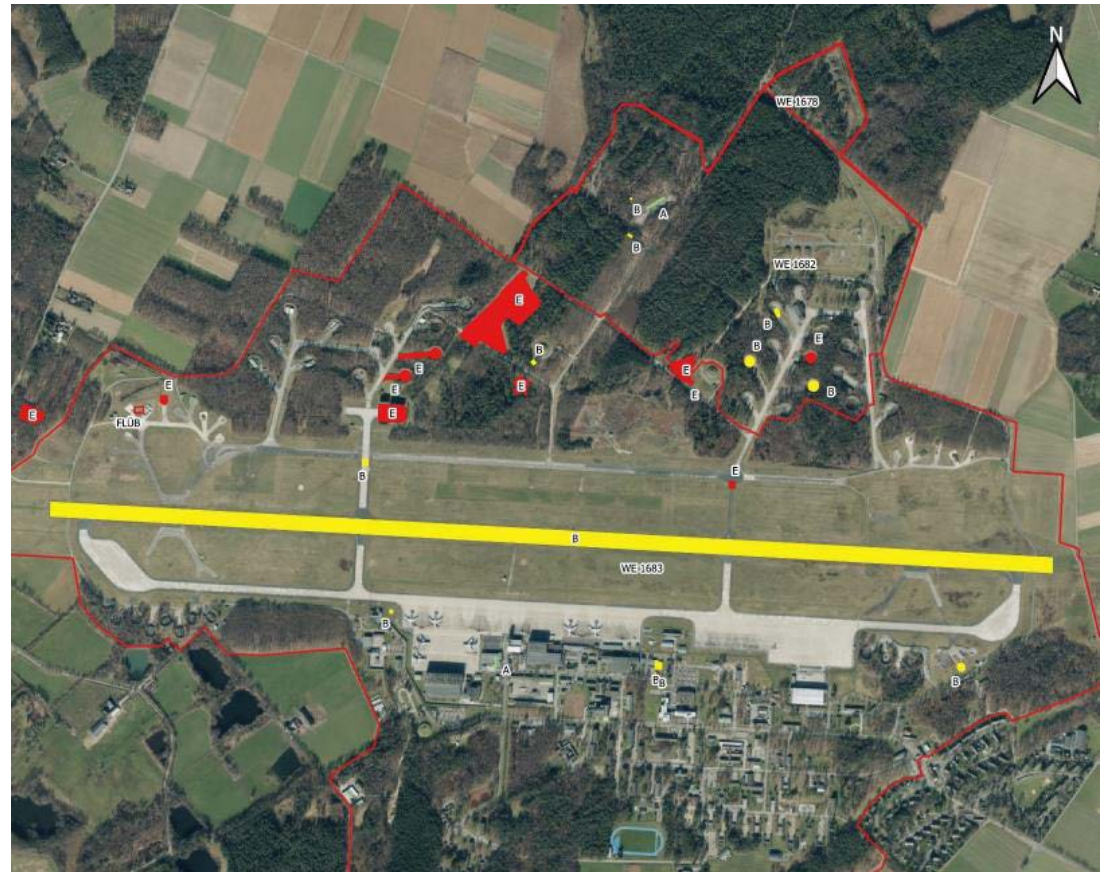
Results and further action

- sufficient suspicion of a harmful soil change for 11 sites
- highly probable that the observed PFAS groundwater pollution originates from the air base or training ground
- still a lack of sound data for final risk assessment and hence, for a weighed decision on possible source remediation
- detailed investigation of the contaminated sites in category E is planned in the near future, i.e.,
 - extent of contamination
 - risk assessment for the impact pathway soil-groundwater
