PFAS-CONTAMINATION MANAGEMENT GEILENKIRCHEN-TEVEREN

Commissie AWACS Limburg, 28 June 2023

BAIUDBw, Germany

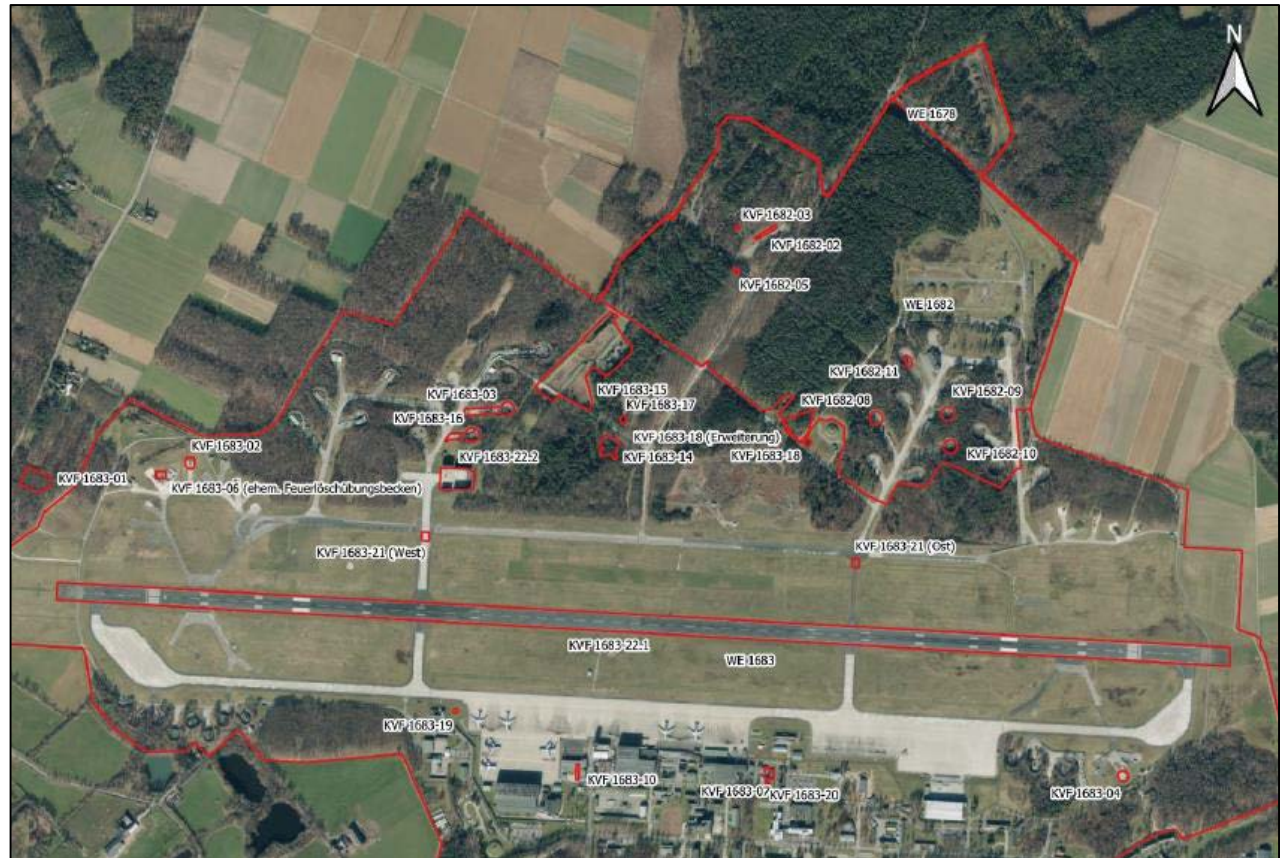
Scope of investigation

- 27 suspected contamination sites were identified in Phase I (18 Air Base and 9 Training Ground)
- Soil investigations:
 - 188 small ramm drillings
 - 5 sediment samples
 - analysis of 13 different PFAS substances (2:1 leachate) in 373 soil samples
